## AERIAL PHOTOGRAPHIC ANALYSIS OF EIGHT HAZARDOUS WASTE SITES

Indiana

PARROTT ROAD DUMP

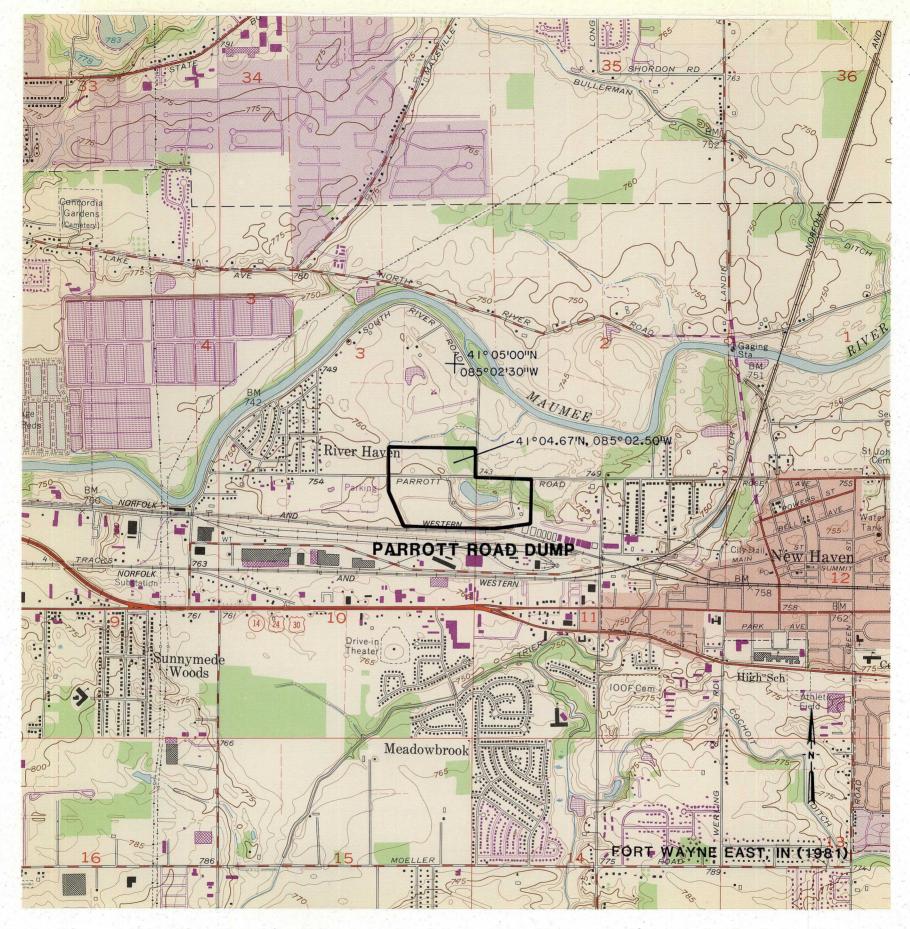
Figure 21. Site location, Parrott Road Dump, New Haven, Indiana. Scale 1:24,000.

The Parrott Road Dump which covers 32 hectares (80 acres) in New Haven, Indiana, is situated between the Norfolk and Western Railroad and the Maumee River (Figure 21). Parrott Road divides the dump into northern and southern portions. Regional drainage is to the east along the Maumee River. Drainage from the site is along a drainage ditch which parallels the borders of the site and eventually flows into the river.
